104 EAST 10TH STREET  
COMMUNITY BOARD 3  
LANDMARKS SUBCOMMITTEE  
AUGUST 25, 2023

PROJECT  
**104 E 10th Street**  
104 E 10th St., New York, NY 10003

LPC SUPPLEMENTAL

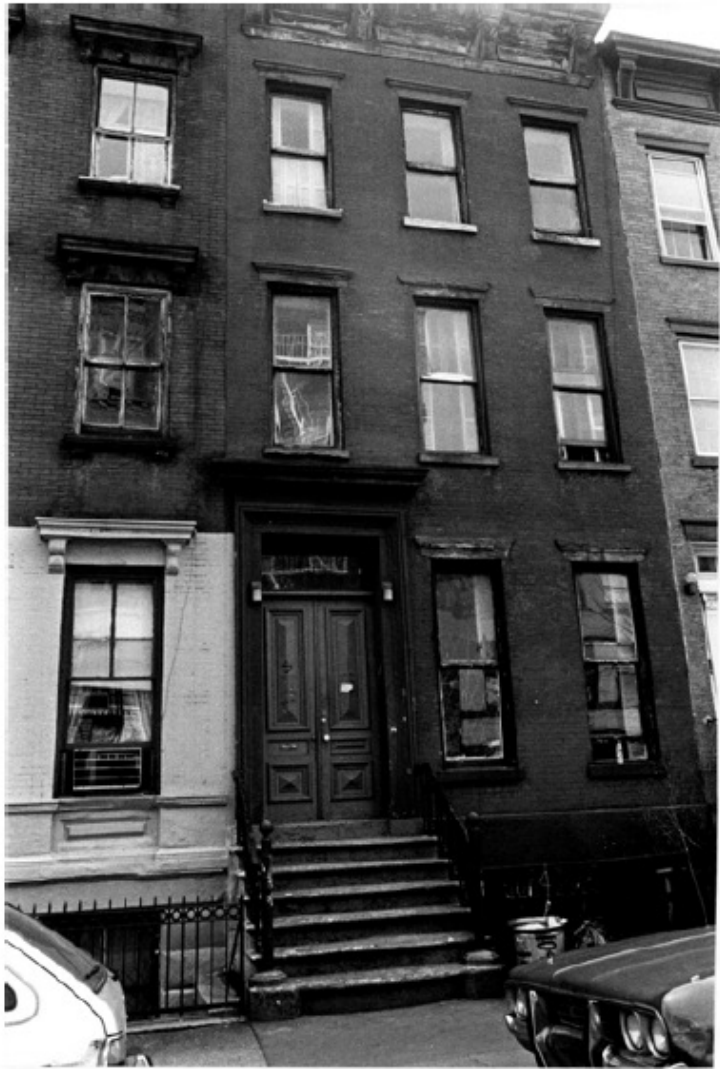
1 DESIGNATION PHOTO - 1984  
LPC DESIGNATION REPORT

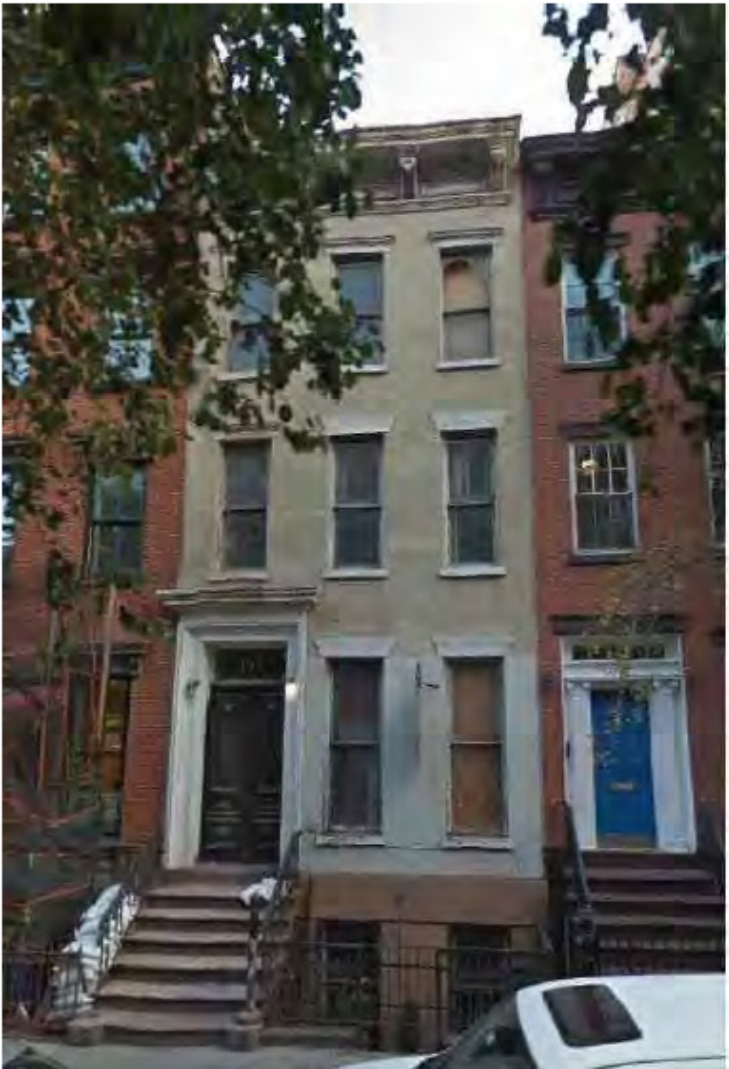
3 CONDITION BEFORE RENOVATION - MARCH 2019  
PHOTO BY ARCHITECT

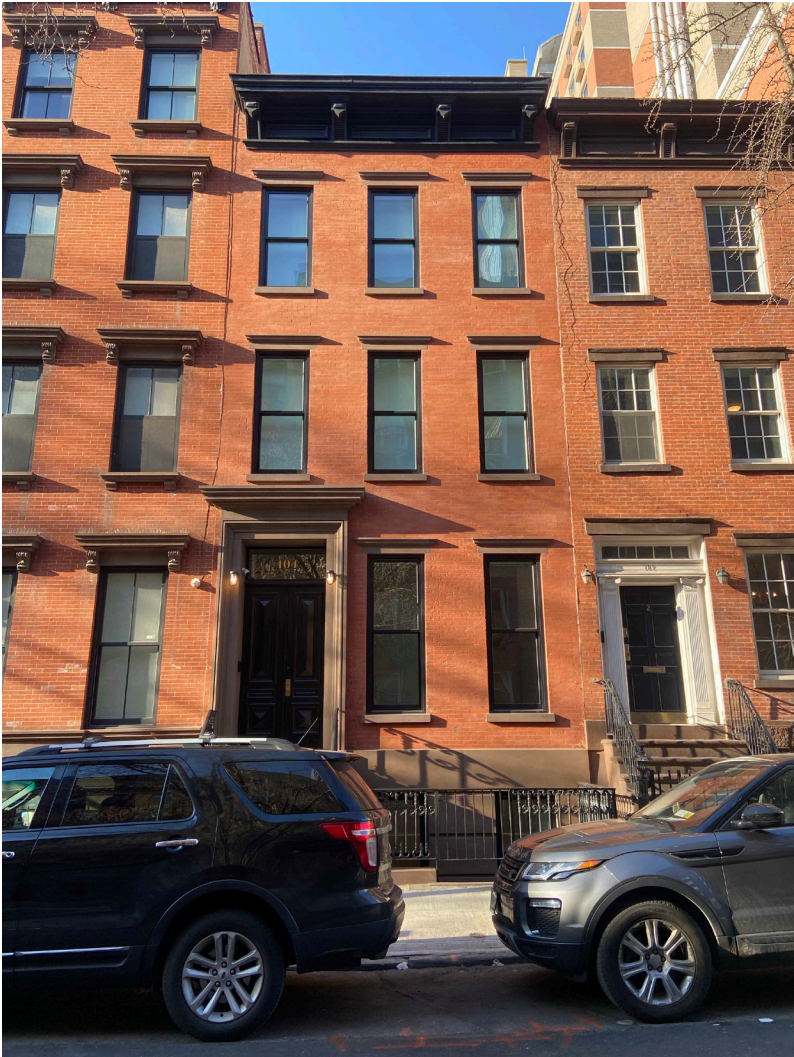
1 BUILDING ELEVATION - MARCH 2023  
PHOTO BY ARCHITECT

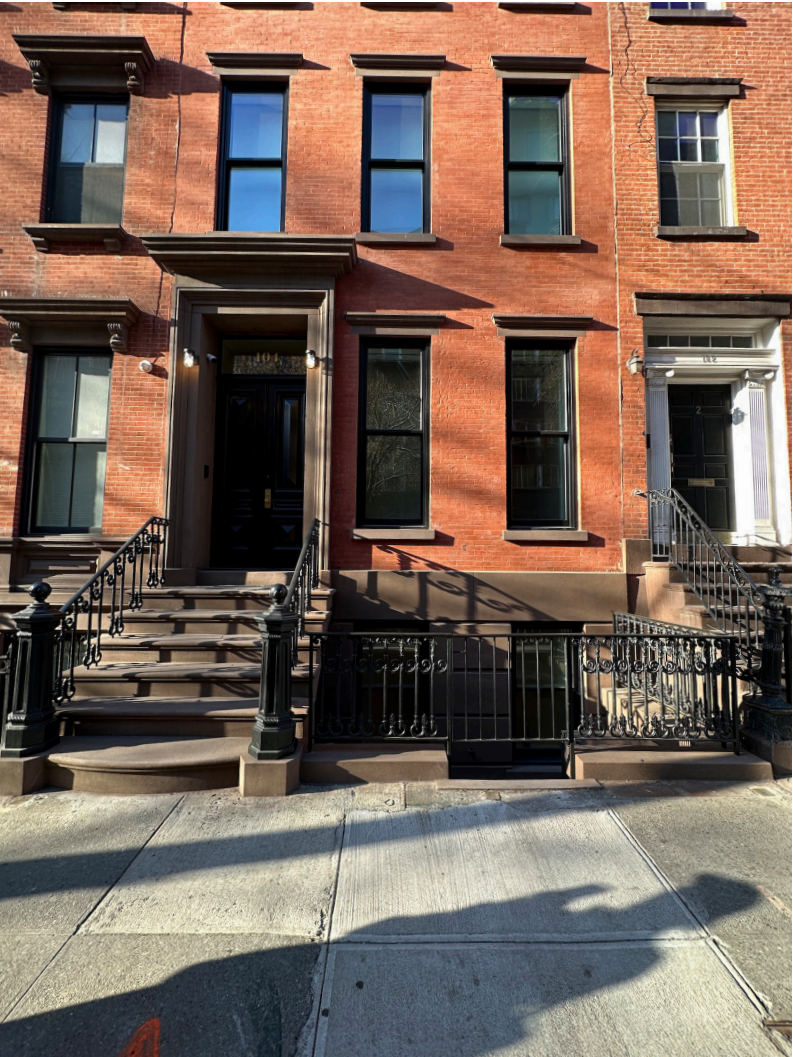
2 AREAWAY CLOSEUP - MARCH 2023  
PHOTO BY ARCHITECT

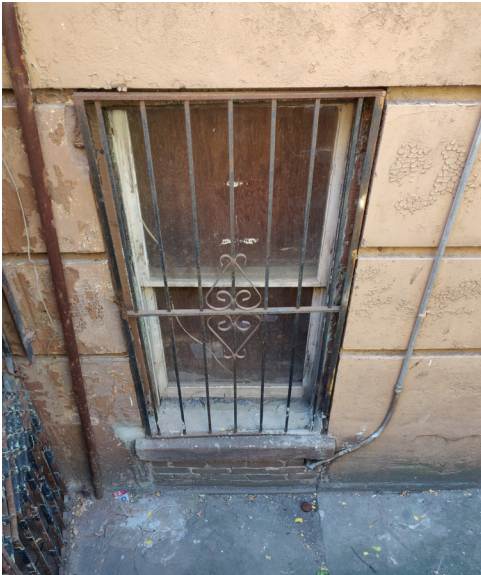
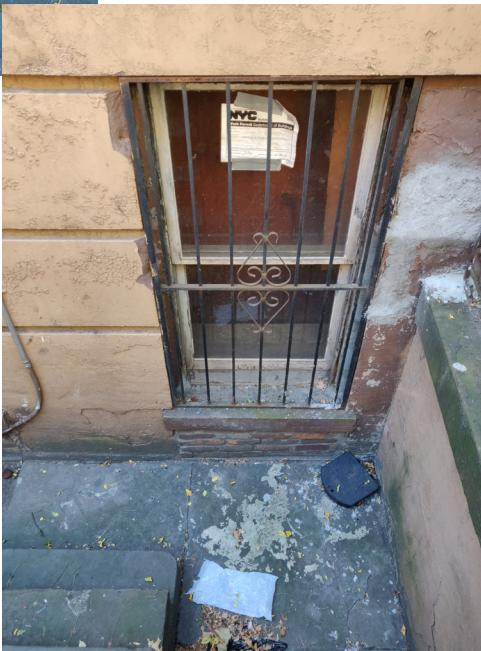
Address: 104 East 10th Street  
Borough/Block/Lot: MANHATTAN / 465 / 109  
Community District: MN-3  
Landmark: St. Mark's Extension - Historic District  
Violation Date: 12/21/2009  
Violation Text: Garden floor window guards replaced without permit(s).  
Violation Status: Warning Letter

The previously installed window guards were replaced without permit and were the impetus for the initial LPC violation.

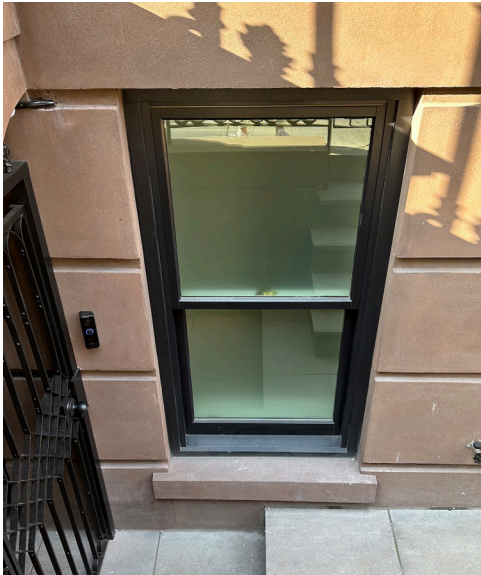
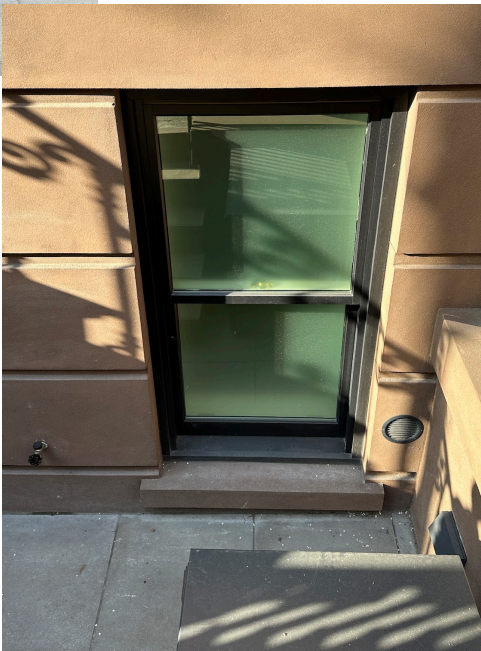
All windows at the front facade were replaced with approved, historic equals. Unpermitted window guards at the garden level windows were removed.

There is no historic record of the original design or intent. We know there was a violation filed in 2009 for unpermitted removal and replacement, but the exact nature of the original guards is unknown.

We are requesting to forgo replacement as any reconstruction would need to be derived from secondary references. Further, we believe unguarded windows offer a more consistent and uniform reading across all windows on the front facade and is not in conflict with the aesthetic make up of the block. As you will see in reference photos, there is a mix of guarded and unguarded windows in the St. Marks Historic District.

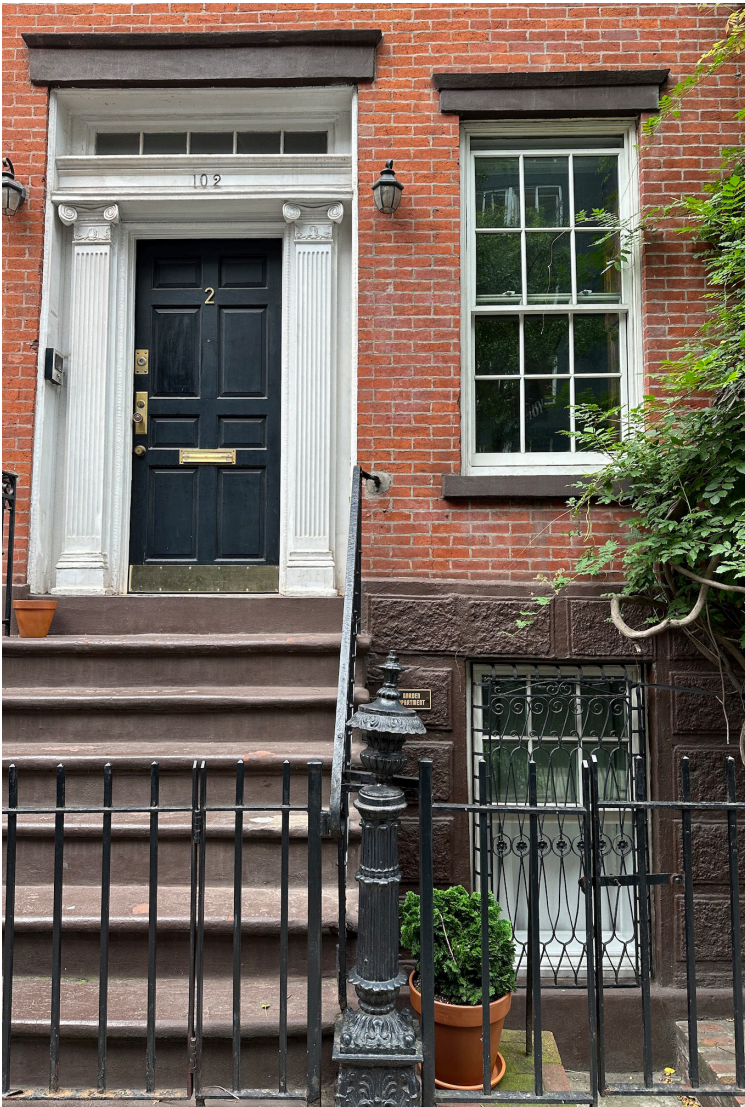
01 102 E 10th St (Non-Historic Window Guard)  
PHOTO BY ARCHITECT  
Analysis:  
The window guards at neighboring building 102, which together with 104 comprise the totality of the St. Marks historic district extension, seem to be of the same vintage as the non-coforming guards previously installed at 104.

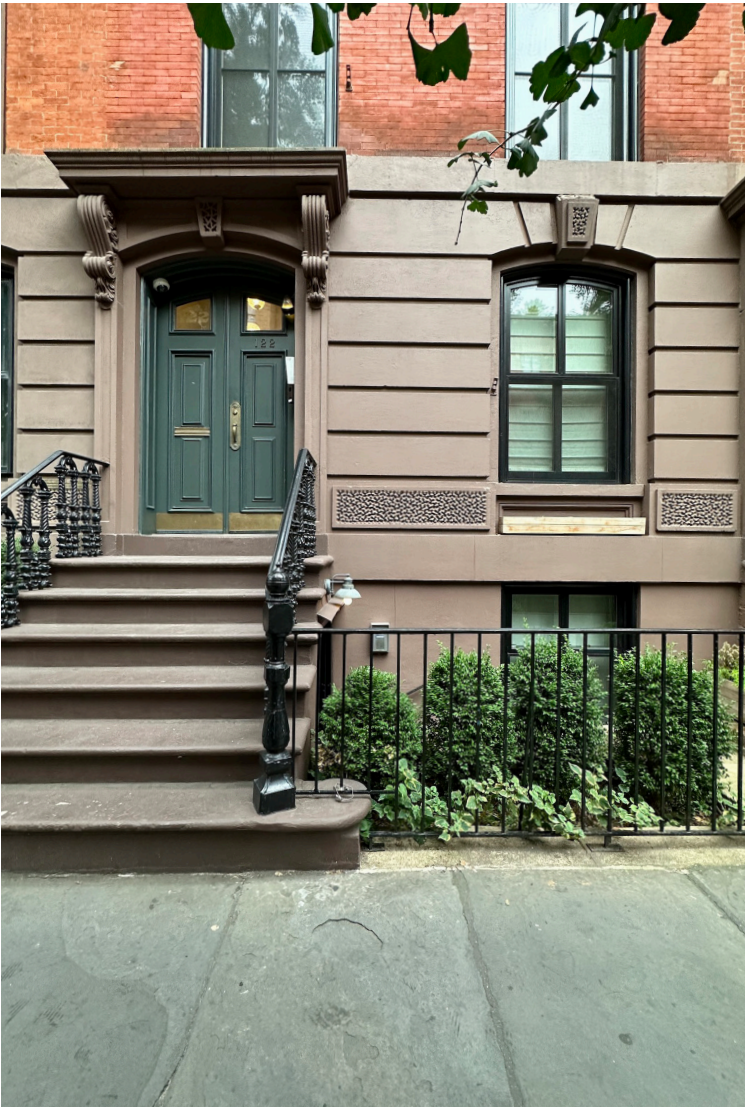
02 122 E 10th St (No Window Guard)  
PHOTO BY ARCHITECT  
Analysis:  
Townhouse 122, located on the same south block as 104, has no window guards installed at the garden level windows.

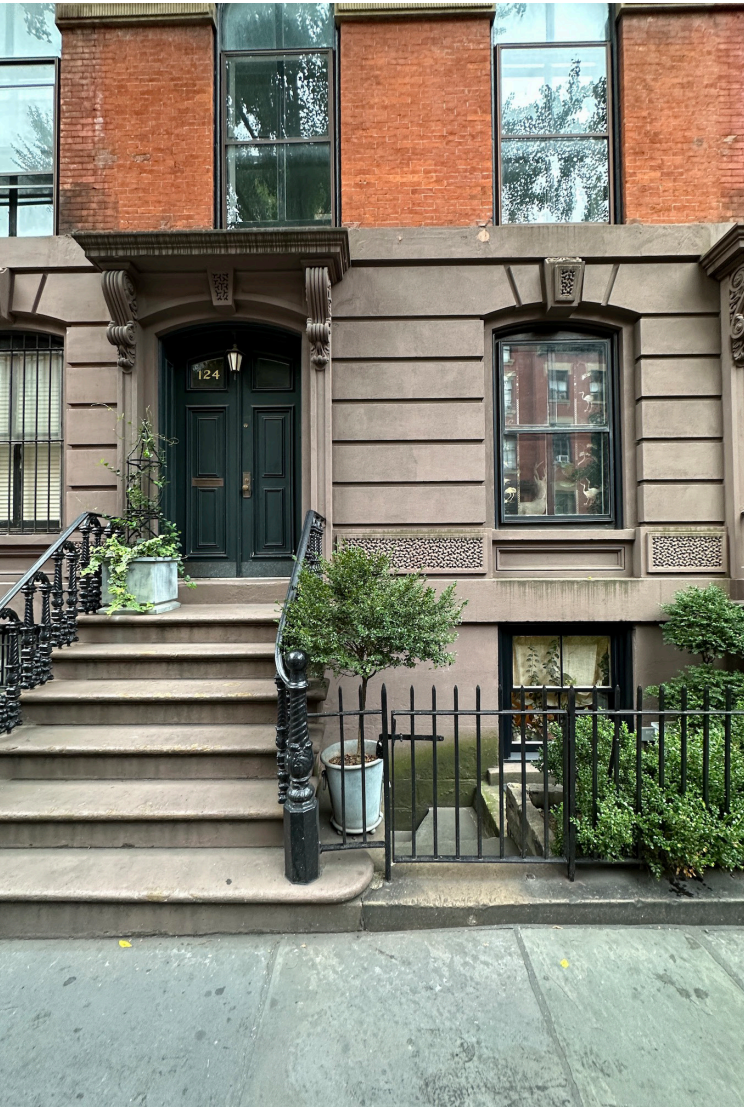
03 124 E 10th St (No Window Guard)  
PHOTO BY ARCHITECT  
Analysis:  
Similarly, townhouse 124, located on the same south block as 104, has no window guards installed at the garden level windows.

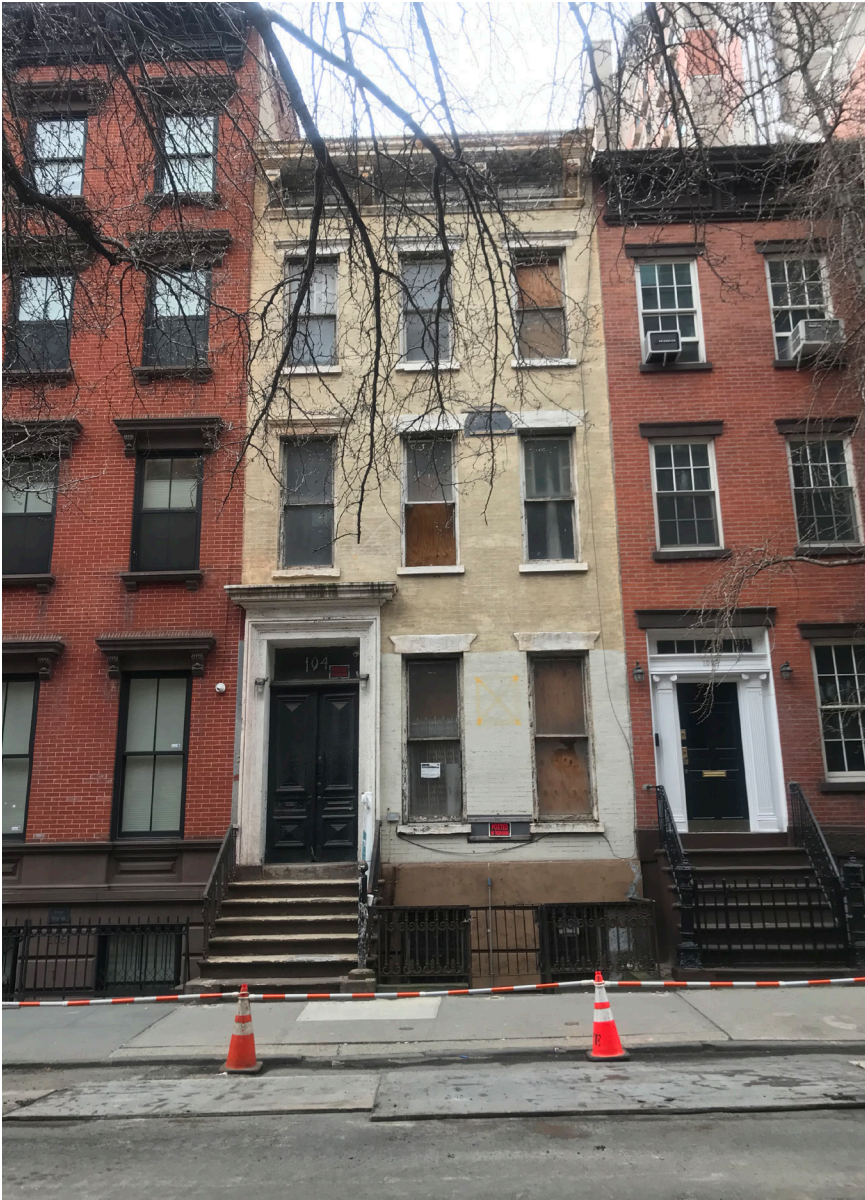
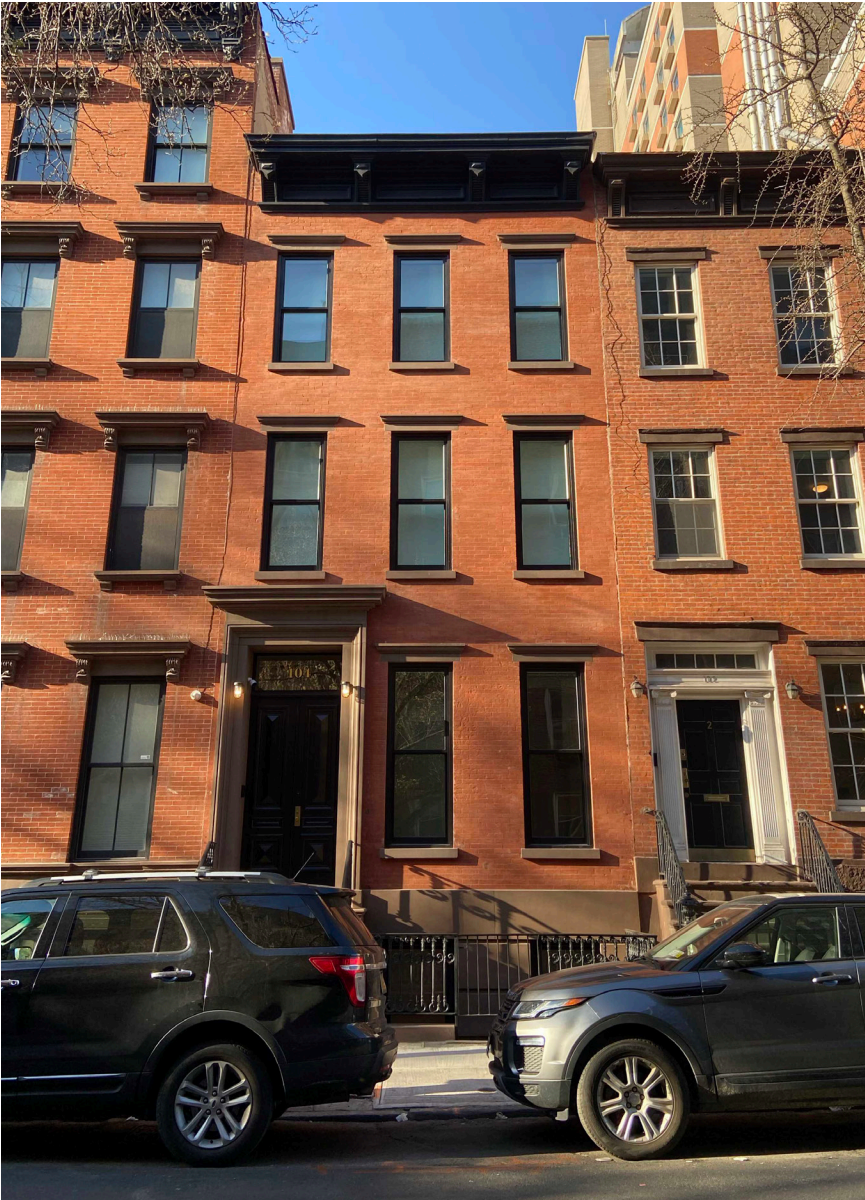
Violation Text: The ongoing facade work (incl. paint, stripping, etc. Cont.: 'Boge') without permits.

An extensive and careful process, as described in filed and approved drawings, was undertaken to restore the masonry facade from it's derelict condition. This included detailed correspondance and multiple on-site metings with preservationist, Katherine Redd, to ensure historic accuracy in terms of overall aesthetic. To everyones surprise, it was determined that the original mortar was a brick color and farily flush with the face of the bricks, resulting in uniformly colored and smooth appearance of the facade.

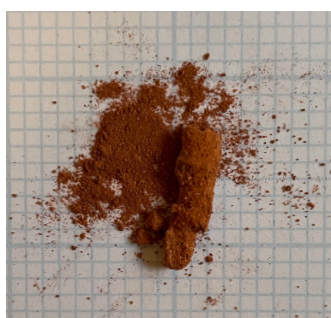
[left] Venetian Red Powder  
[right] Original Grout Sample (interior face)

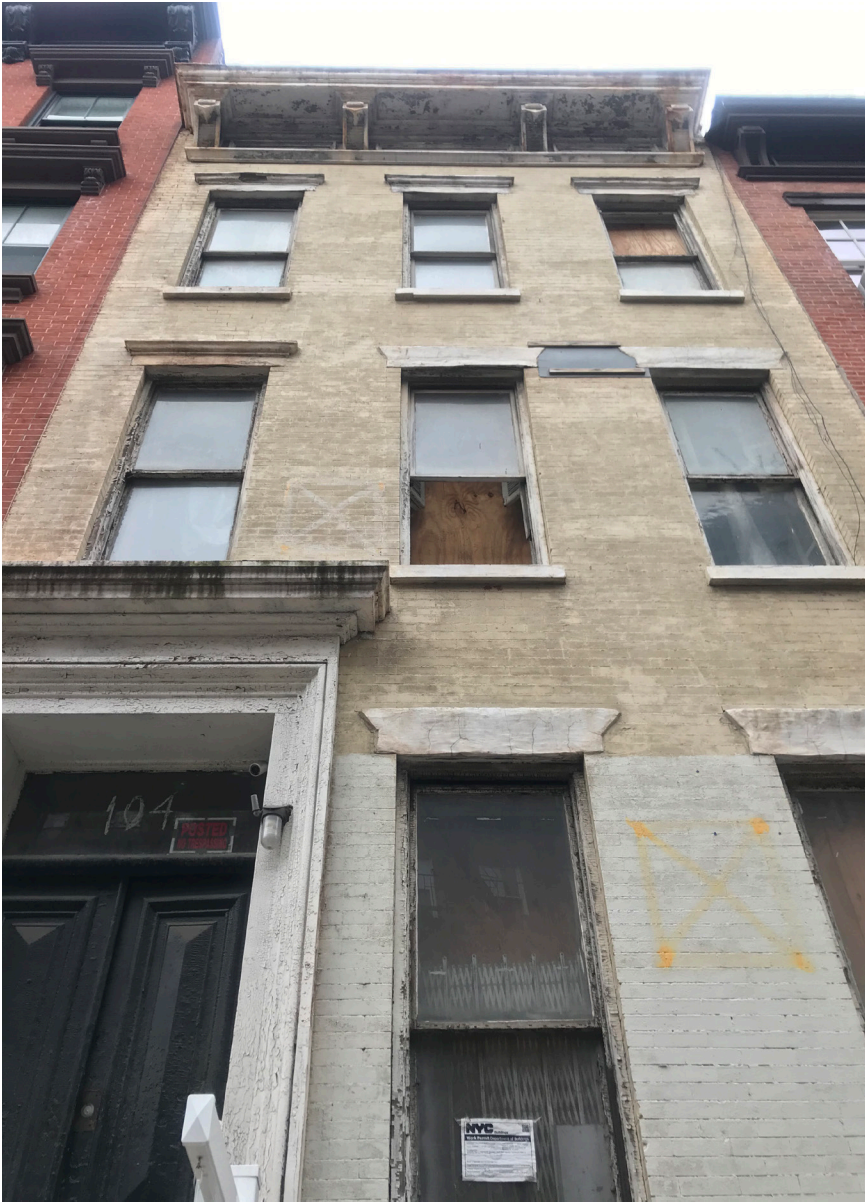
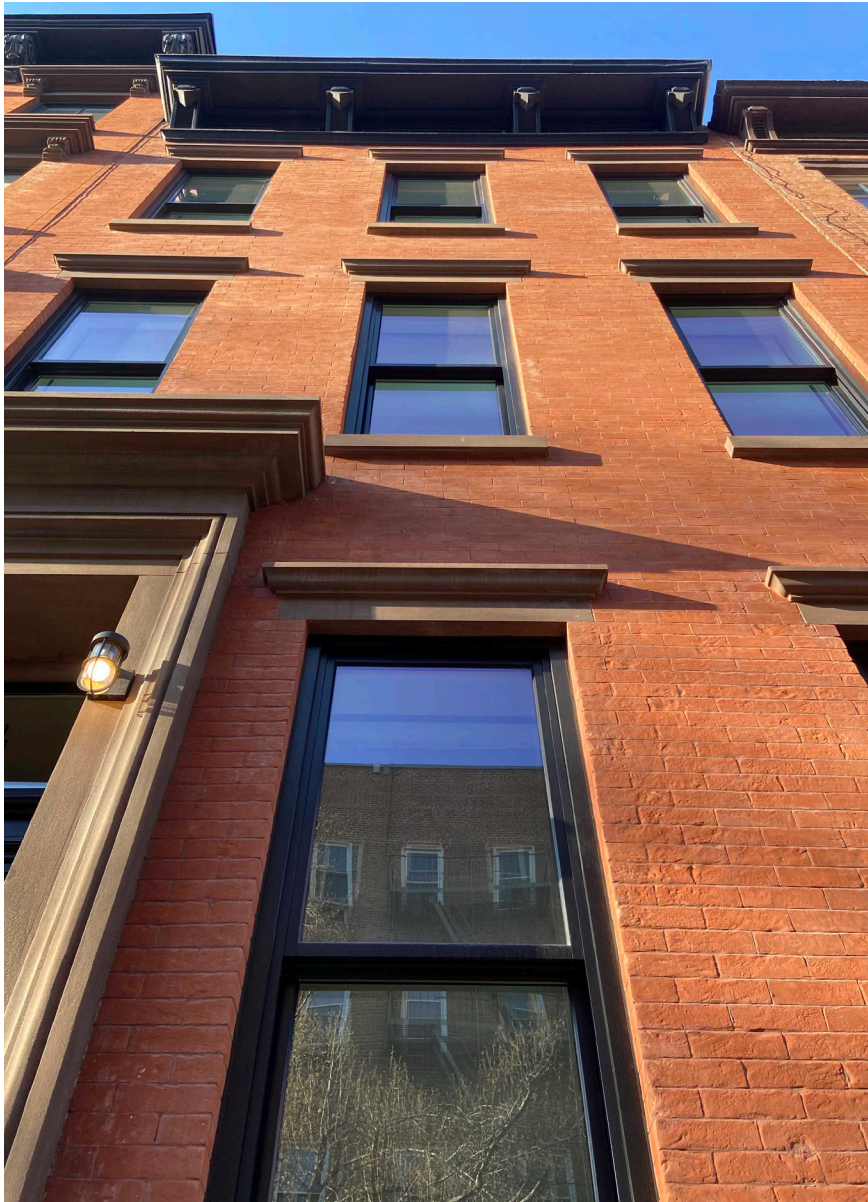
Address: 104 East 10th Street	Community District: MN-3
Borough/Block/Lot: MANHATTAN / 465 / 109	Landmark: St. Mark's Extension - Historic District
Violation Date: 12/21/2009	Violation Text: Lintels shaved at parlor floor and second floor without permit(s).
Violation Status: Warning Letter

All lintels and sills at the front facade were rebuilt per approved drawings to match historic record, including shaved lintels at the parlor and second floor windows.

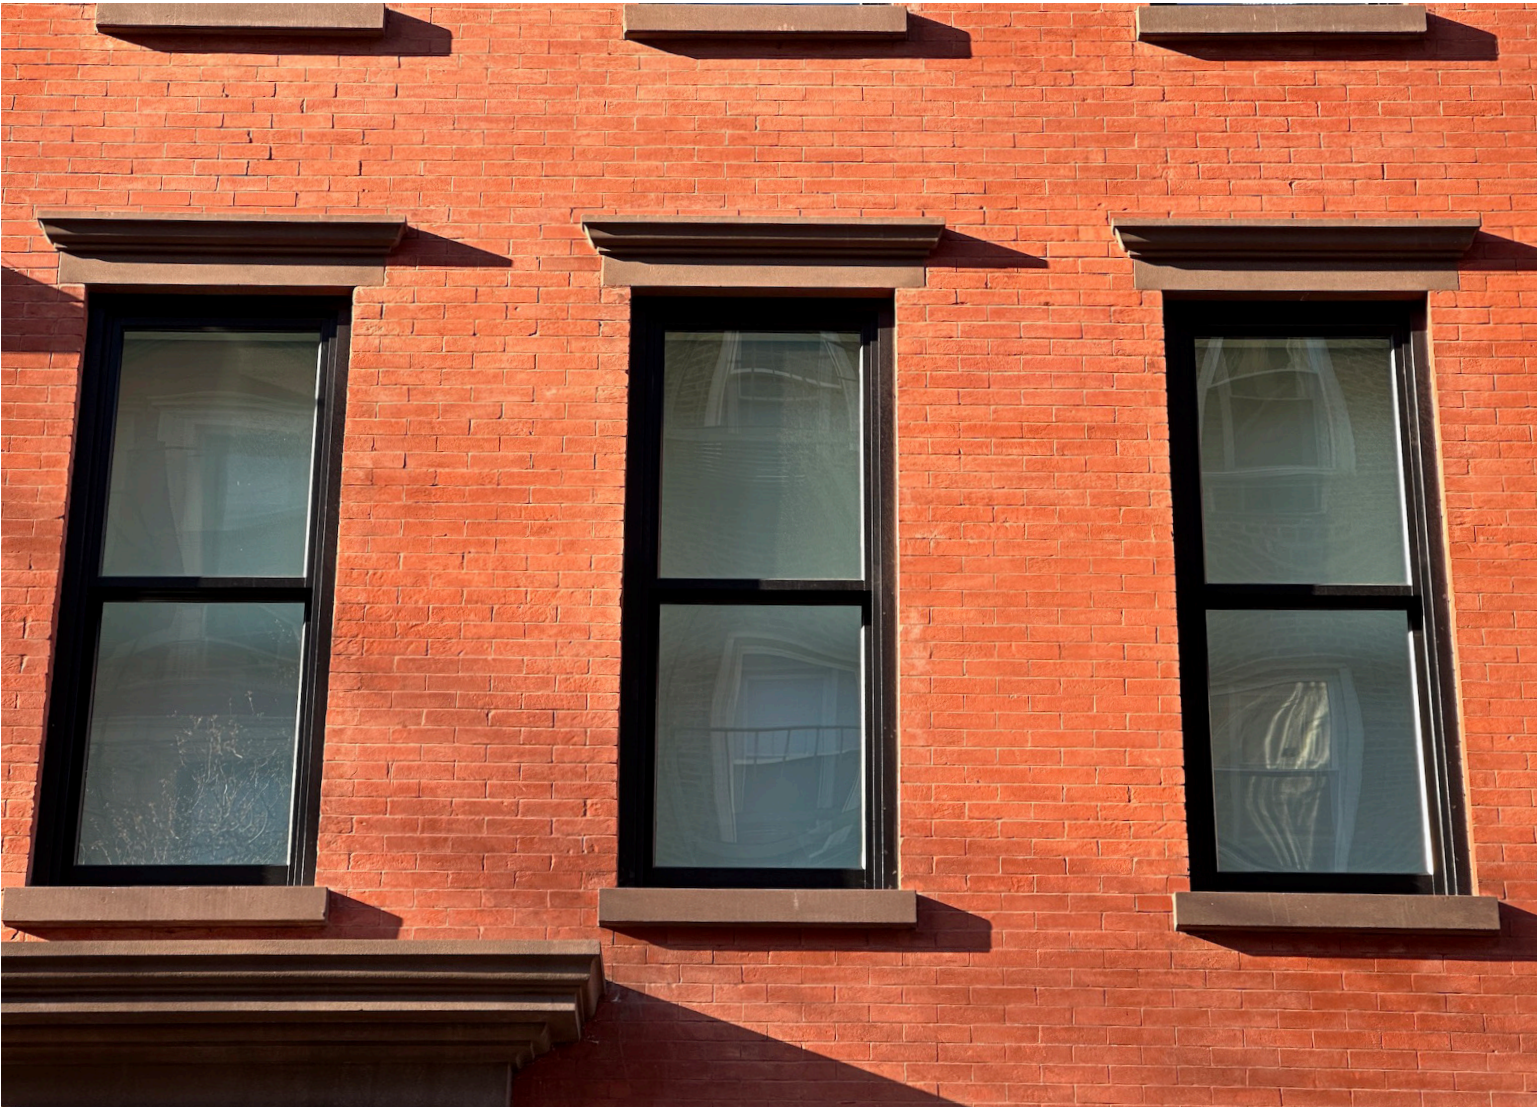
02 DETAILS - NEW WINDOWS, LINTELS & SILLS  
PHOTO BY ARCHITECT

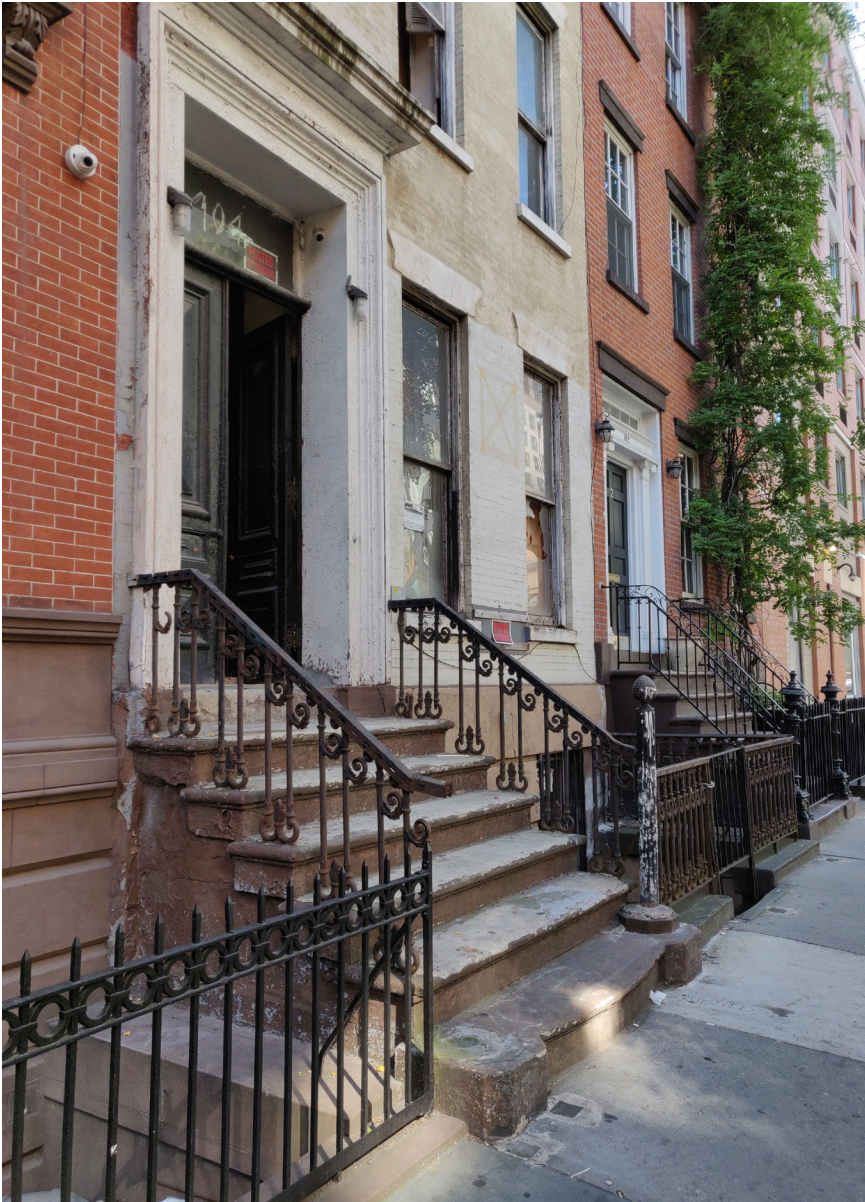
Violation Text: Newel posts altered/removed without permit(s).

NEWEL POST - PREVIOUS CONDITION

Missing/existing newel posts were restored with vintage newels to match condition and character of earliest available record which is the 1940's tax photo.

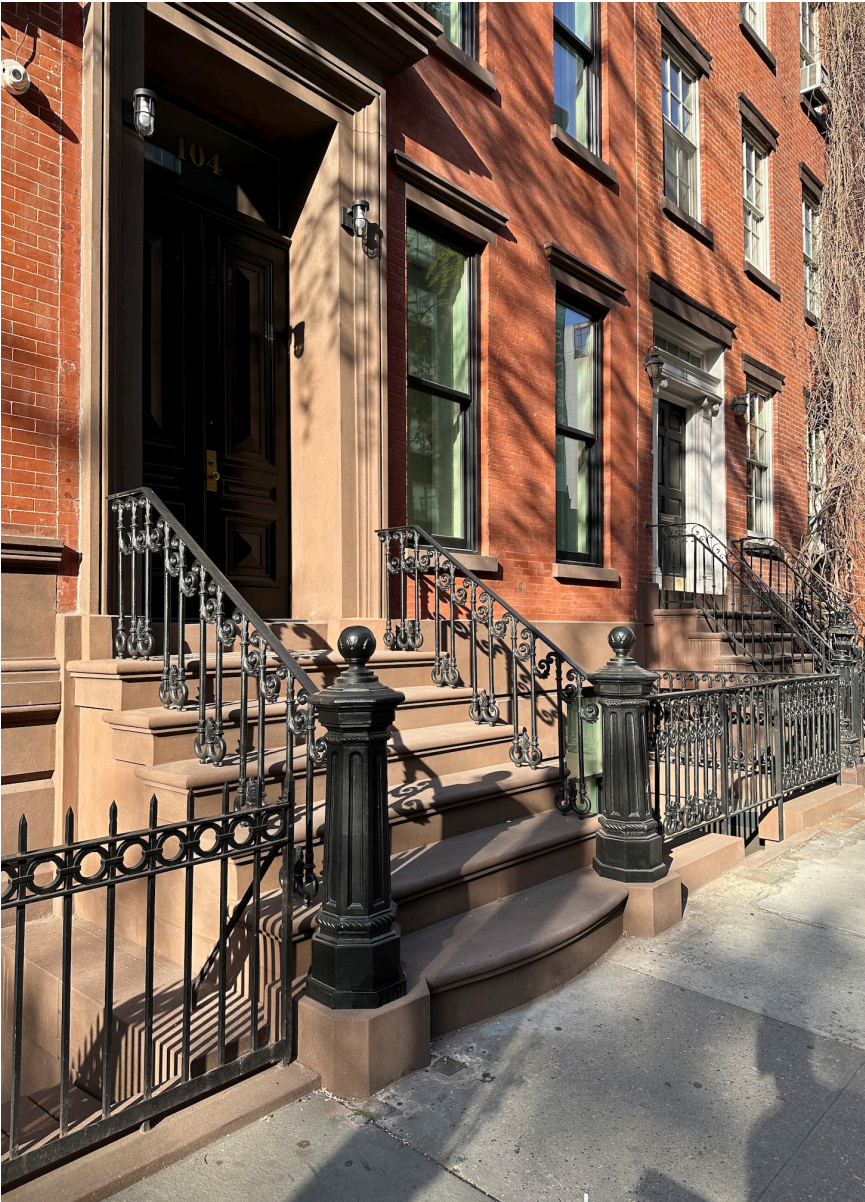
NEWEL POST - RESTORED CONDITION

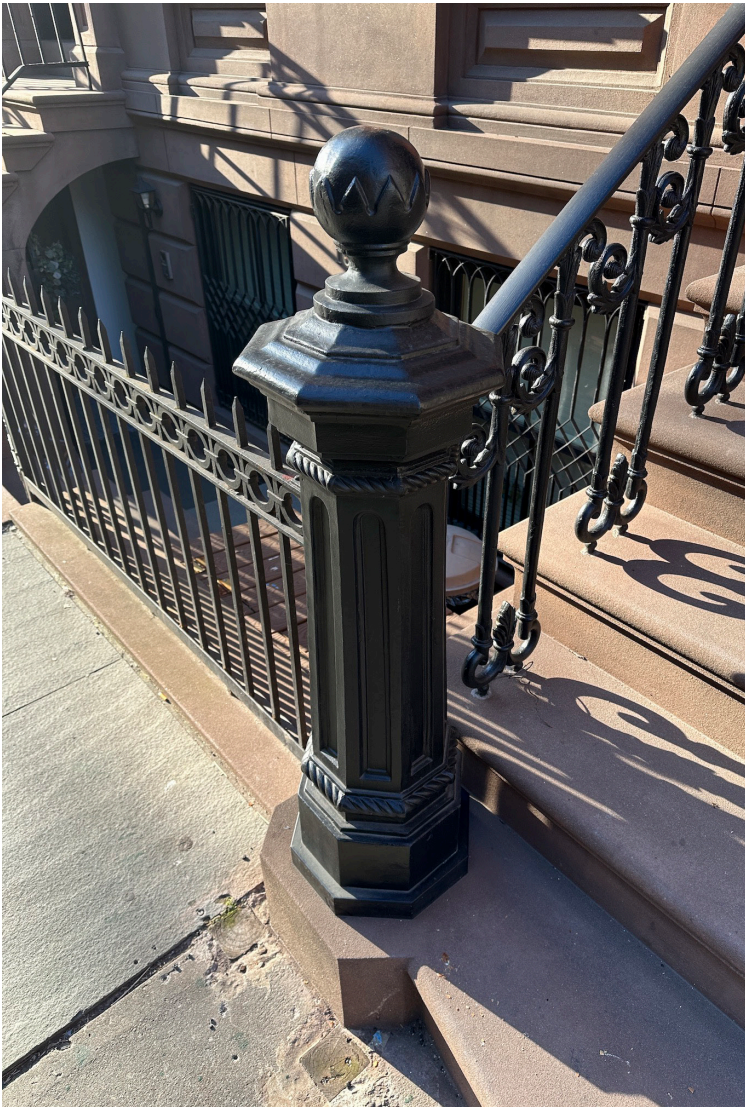
01 NEWEL POST  
PHOTO BY ARCHITECT

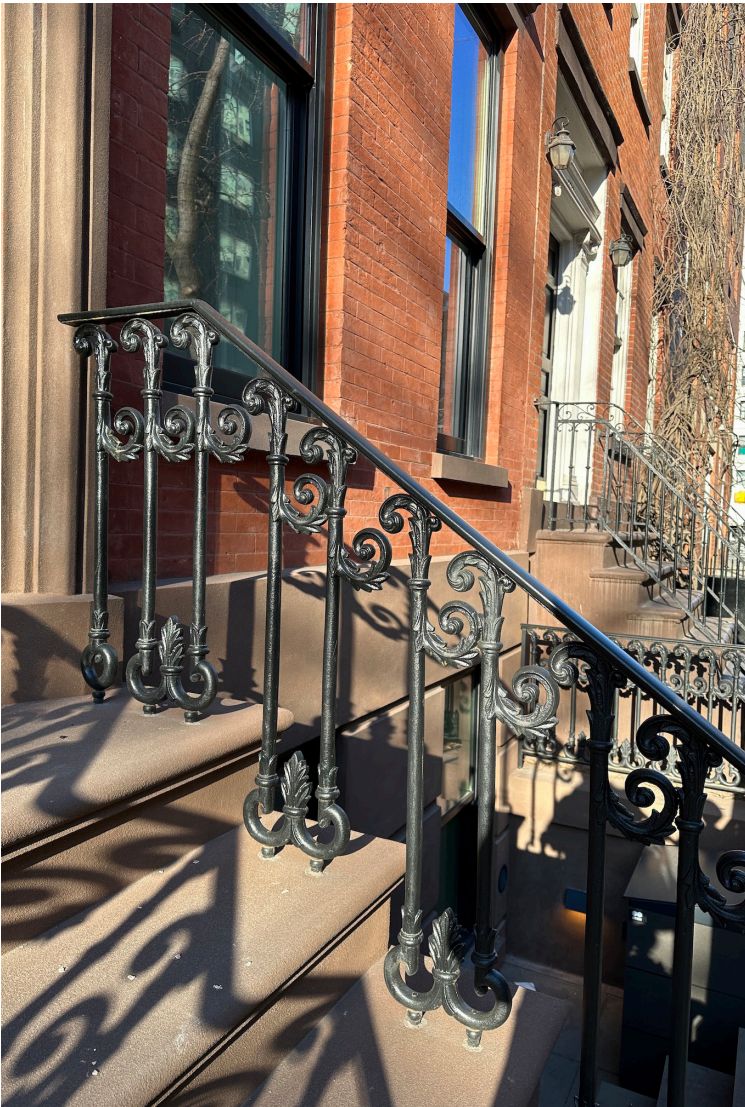
02 STAIR BALUSTER  
PHOTO BY ARCHITECT

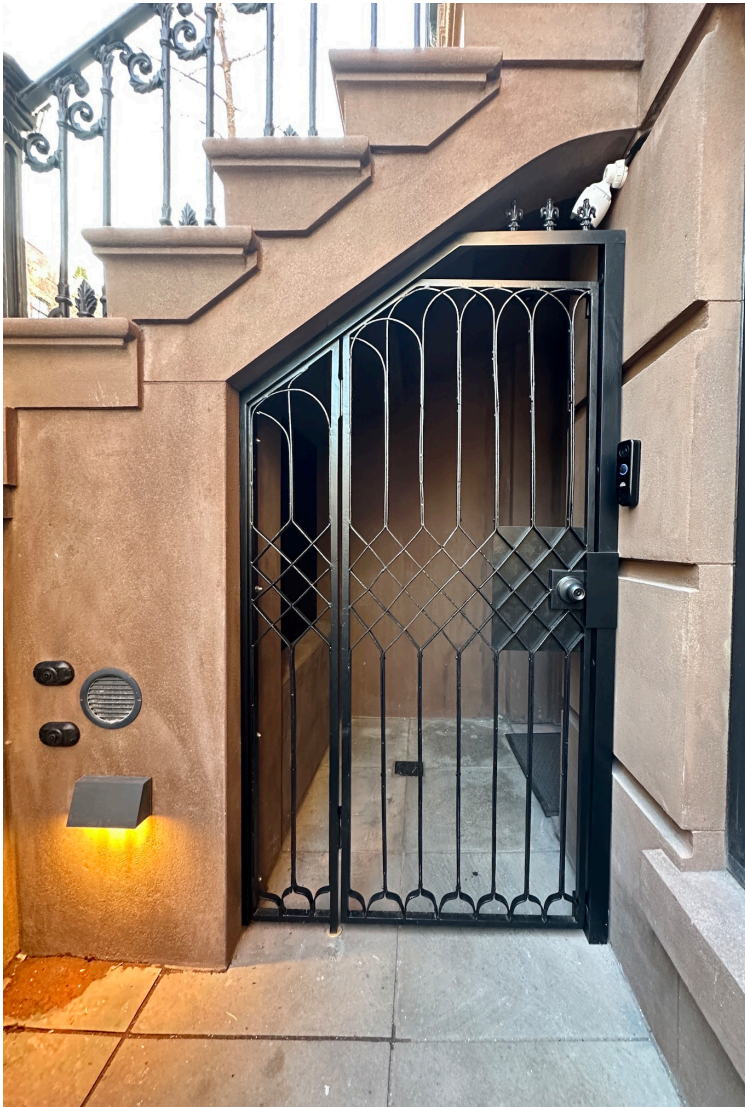
03 UNDERSTOOP GATE  
PHOTO BY ARCHITECT

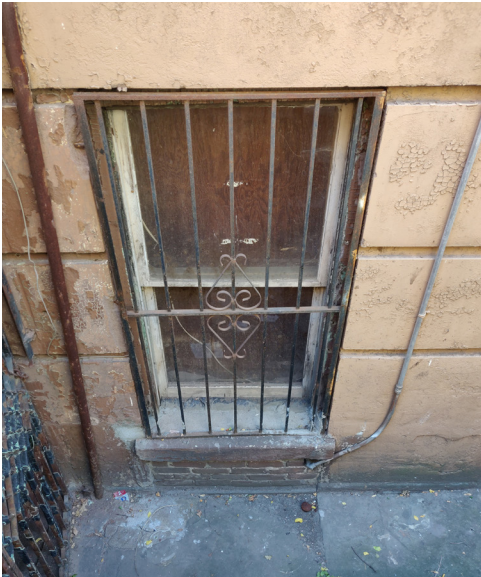
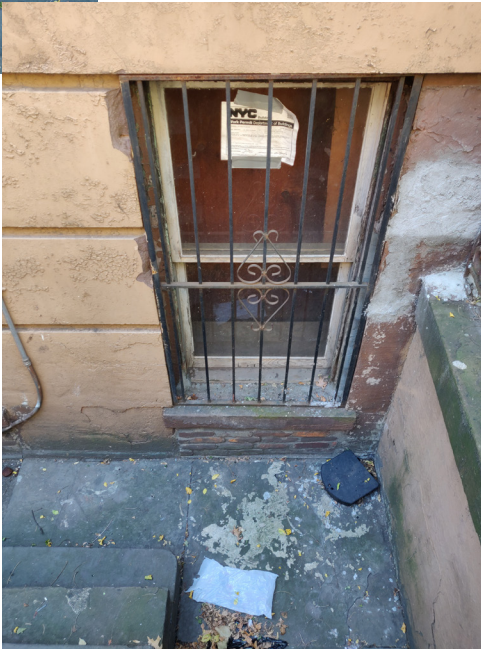
Violation Text: Garden floor window guards replaced without permit(s).

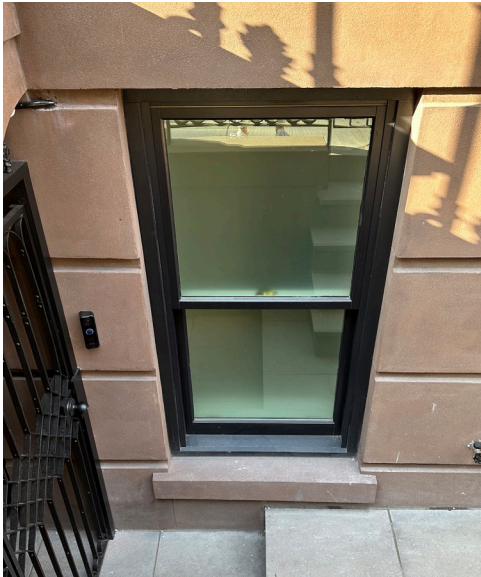
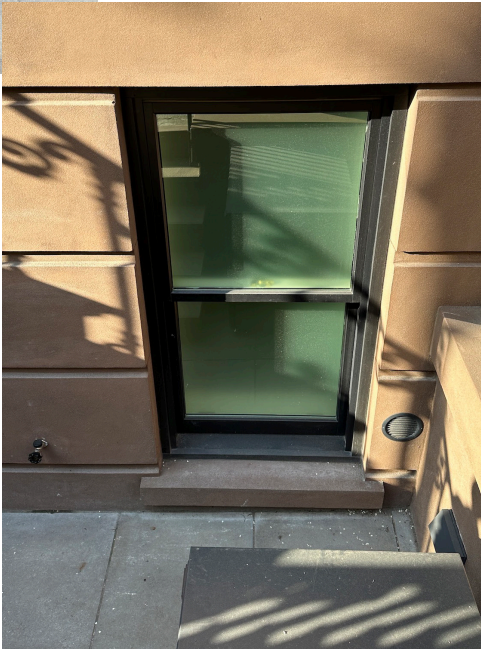
All windows at the front facade were replaced with approved, historic equals. Unpermitted window guards at the garden level windows were removed.

There is no historic record of the original design or intent. We know there was a violation filed in 2009 for unpermitted removal and replacement, but the exact nature of the original guards is unknown.

We are requesting to forgo replacement as any reconstruction would need to be derived from seconary references. Further, we believe unguarded windows offer a more consistent and uniform reading across all windows on the front facade and is not in conflict with the aesthetic make up of the block. As you will see in reference photos, there is a mix of guarded and unguarded windows in the St. Marks Historic District.
